PROJECT: Midnite Mine Remediation REPORT NO: 2021-31

OWNER: Newmont/Dawn Mining OPERATOR: Newmont/Dawn Mining

SUMMARY OF WORK ACTIVITIES OR EVENTS FOR THIS REPORTING PERIOD:

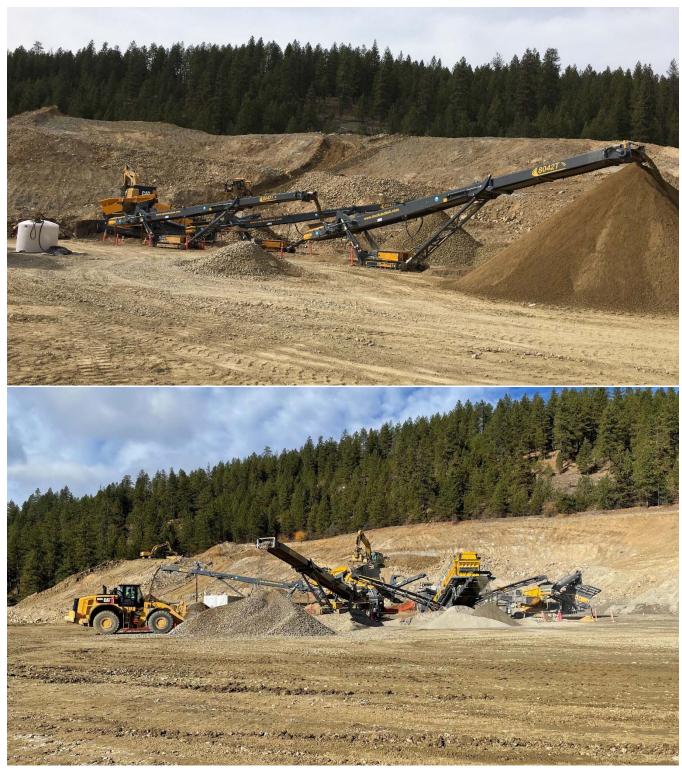
Figure 1 – Crushing and screening operations at the HSWRP on 1 Apr (top) and 27 Oct 2021 (bottom), view looking northwest.

- SLV Earthmovers continued crushing and screening operations at the Hillside Waste Rock Pile
 (HSWRP). They continue to produce Drain Gravel and Geomembrane Bedding. Newmont hauled these
 materials to stockpile locations designated in the 2021 Crushing and Stockpiling Work Plan (Stantec,
 2021). Estimated quantities of materials produced are presented in Table 1.

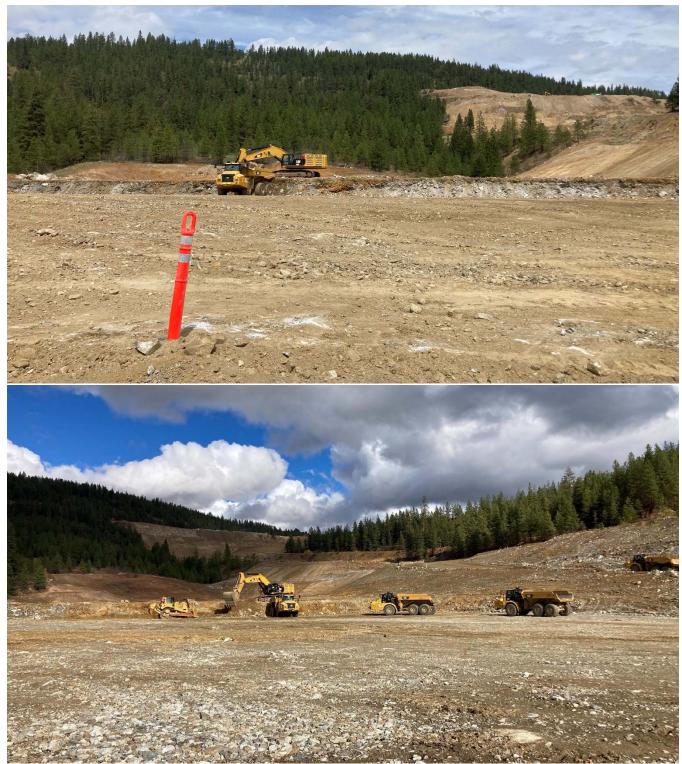
Figure 2 – Excavating, loading, and hauling low activity/low reactivity material from the South Waste Rock Pile (SWRP) on 30 Apr (top) and 25 Oct 2021 (bottom), view looking north.

- Newmont excavated, hauled, and placed low activity/low reactivity material from the west side of the South Waste Rock Pile (SWRP). Newmont placed these materials in the Pit 4 Waste Containment Area (WCA).

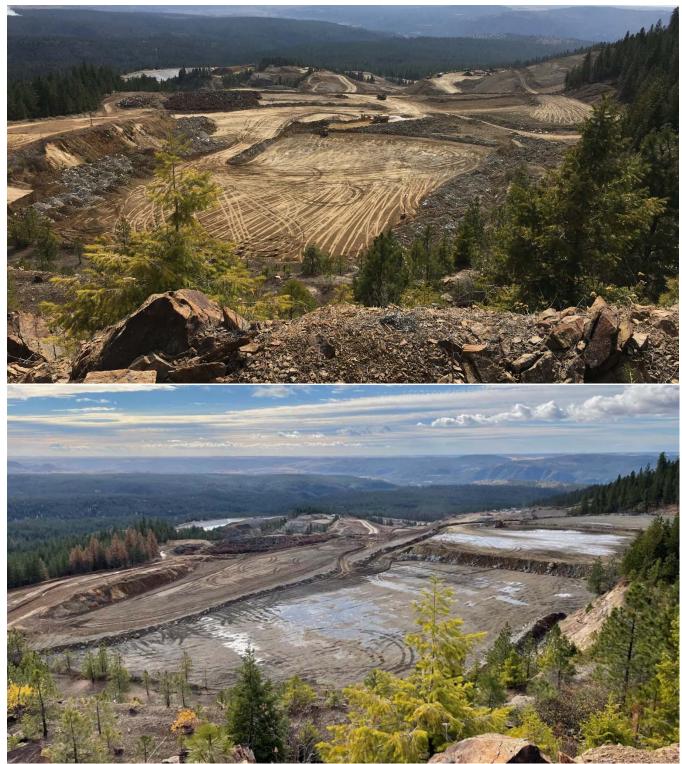
Figure 3 – Placement of low activity/low reactivity material in Pit 4, view from the Pit 4 Overlook on 1 Apr (top) and 27 Oct 2021 (bottom), looking south.

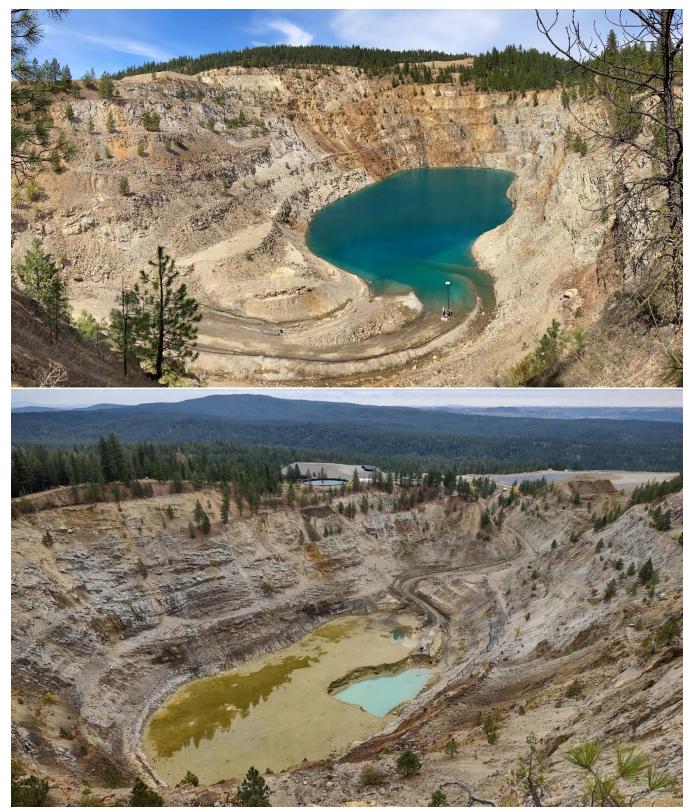
Figure 4 – Pit 3 water level on 28 Apr (top) and on 15 Oct (bottom).

- Newmont continued pumping water from Pit 3 into the South Pond.
- Stantec performed the weekly South Pond Embankment inspection and downloaded transducer data from the South Pond Piezometer. The embankment remains stable and water levels in the piezometer remain steady.

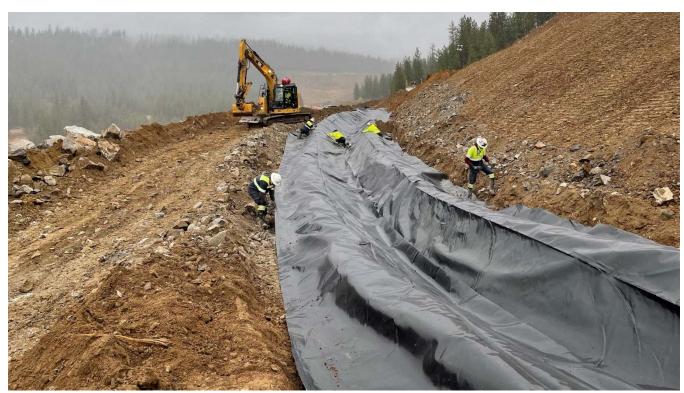
Figure 5 – Installing liner in the SWRP East SWPPP Ditch, view looking northwest.

- Completed SWPPP inspection on October 25. No deficiencies or required changes identified.
- Newmont continued construction of a new lined channel, the SWRP East SWPPP Ditch, to replace the
 previous winter SWPP channel.
- Halme Construction maintained silt fence along Blue Creek Road and began installing winter BMPs.

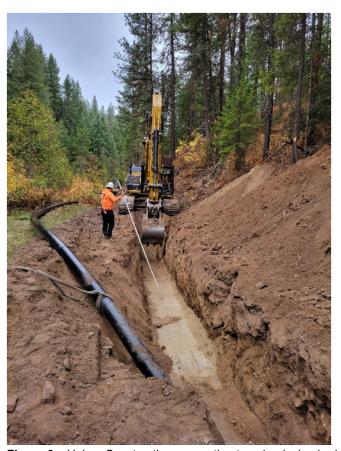
Figure 6 - Halme Construction excavating trench, placing bedding and checking grade along Blue Creek Road

- o Installed pipe along Blue Creek Road between Stations STA 107+22 and 121+50.
 - o Installed Culvert #4 (Sta 120+25).
 - o Placed shoulder gravel on the New Access Road.

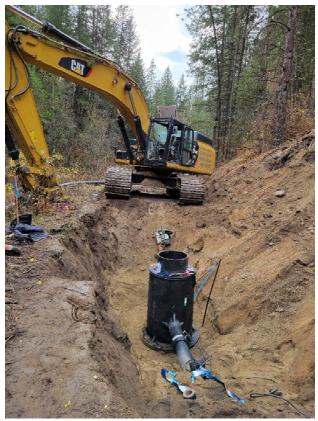
Figure 7 – Halme Construction installing manhole at Station 121+50

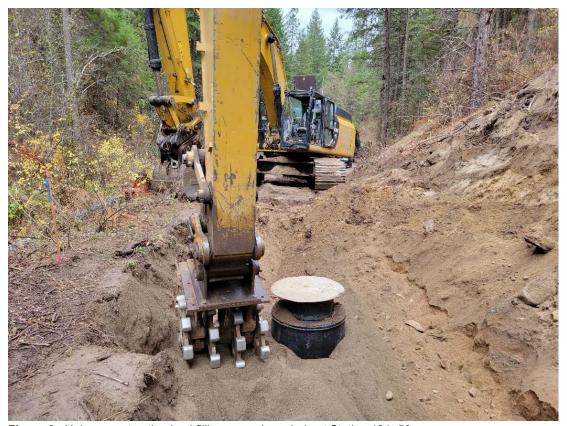
Figure 8– Halme construction backfilling around manhole at Station 121+50

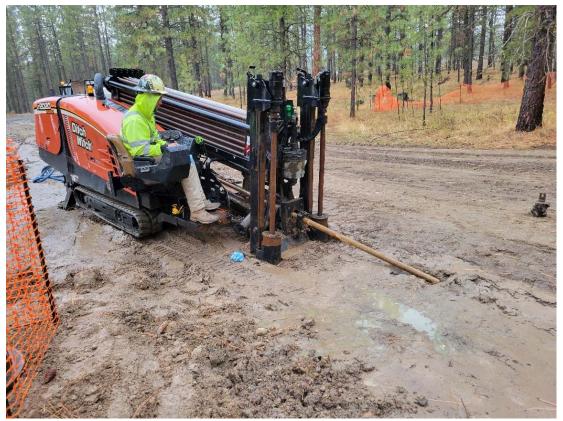
Figure 9– Northwest Line Builders installing conduit under West End Road for fiber optic cable.

- Effluent Pipeline Horizontal directional drilling completed under West End Road and 1.5-inch conduit placed for the fiber optic line scheduled to be installed at a later date.
- New Access Road Notice of Non-Compliance issued on 10/29/2021 NAR Asphalt Compaction
- New Access Road Completed placement of top course material along the shoulder of the NAR.
- Material Delivery Pipe bedding from Lincoln Sand and Gravel.
